MOTORCYCLE IMPACTS TO ROADSIDE BARRIERS – REAL-WORLD ACCIDENT STUDIES, CRASH TESTS AND SIMULATIONS CARRIED OUT IN GERMANY AND AUSTRALIA

Paper Number 05-0095

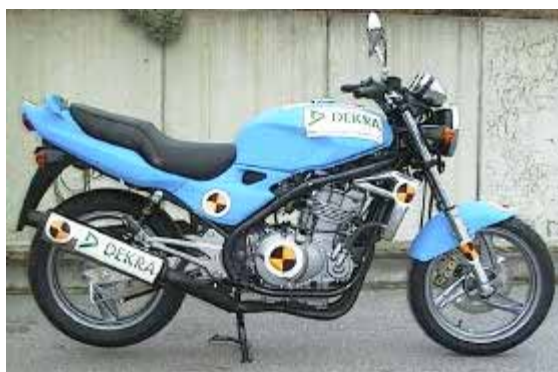
Figure 5. Motorcycle Kawasaki ER 5 Twister as used for all crash tests

All tests were carried out with the same make, model and type of motorcycle being a Kawasaki ER 5 Twister (Figure 5.). The mass of the motorcycle itself was approx. 180 kg and approx. 272 kg with the dummy sitting on the motorcycle and wearing standard protective clothing.

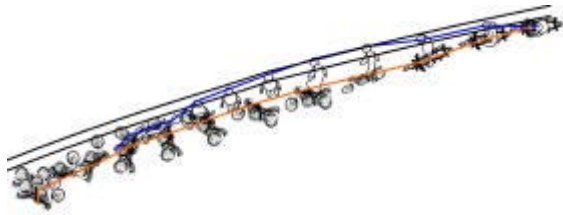
Figure 7. Trajectory of the motorcycle and rider during the first 300 milliseconds after impacting the steel guard rail system EDSP (see Figure 6) determined from analysis of the overhead-view cameras

Figure 7 further illustrates the movement trajectories of the motorcycle and the rider determined from analysis from the films of the overhead-view cameras for a time period of 300 milliseconds after impact into the guard rail. The motorcycle reaches its final rest position 28 m after the point of first contact with the barrier. The distance between the point of first contact and the final rest position of the dummy was 21 m.

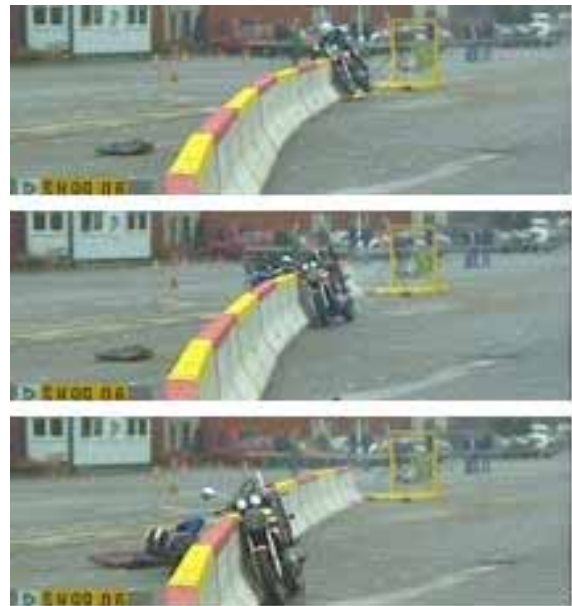
Figure 8. Full-scale crash test of a motorcycle impacting a concrete barrier protection system in an upright position prior to impact moving

The concrete barrier (Figure 8) does not have any aggressive open shaped parts as in the case of the steel-based systems. In this crash test the motorcycle left the sled at 60 km/h prior to impacting the barrier. This was followed by the dummy flying over the top of the barrier. The dummy reached its final rest position on the opposite side of the barrier (Figure 8 and Figure 9). The distance of the final rest position from the point of first contact primary impact location was 26 m for the dummy and 38 m for the motorcycle.

The measured dummy loads again do not indicate any life-threatening injury risk (see Table 2.). The right femur is subjected to a compressive load of 4.5 kN being clearly below the injury limit of 10 kN.

Analysis of the film revealed that the motorcycle and the rider were effectively not decelerated during contact with the concrete barrier. As a consequence of this the risk of being deflected by the barrier into oncoming-traffic on the road is clearly higher than for a barrier protection system made from steel. Another disadvantage of concrete barriers is that during an impact they do not dissipate as much kinetic energy via deformation as the systems made from steel.

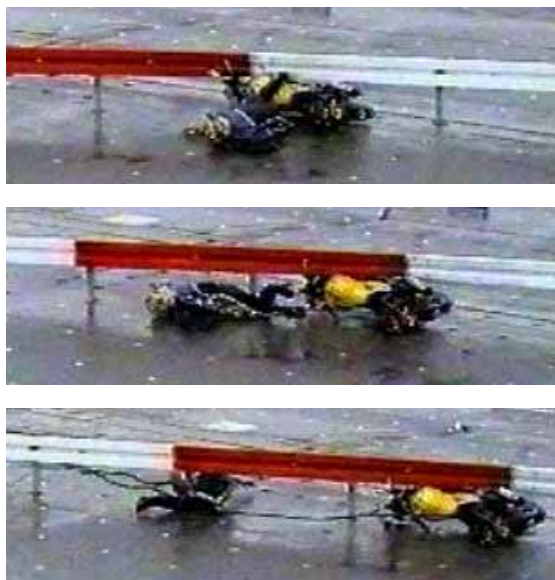
Figure 10. Full-scale crash test where the motorcycle impacts the protection system “Einfache Stahlschutzplanke” ESP by sliding into the barrier

Figure 10 shows the test where the motorcycle slides-on its side and impacting the so called “einfache Schutzplanke” ESP (Figure 1).

The motorcycle’s velocity leaving the sled was 60 km/h. It directly impacted a sigma post at 47 km/h that broke and was bent down to the ground. Immediately after this first primary impact the motorcycle was stopped and remained stuck underneath the guard rail. The dummy separated from the motorcycle and collided with a sigma post. The distance between the location of the primary impact point and the final rest position was 2 m for the motorcycle and 5 m for the dummy.

Table 3 gives an overview of some of the dummy loads measured at the point of first impact onto the protection system and from the second impact onto the ground. Very high loads above the biomechanical limits were measured for the head during the first contact primary impact. Due to the hard impact into the post, the left shoulder joint of the dummy was broken.

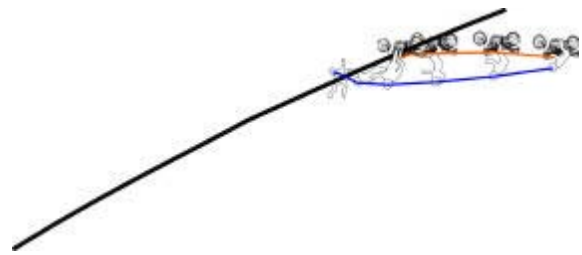
Figure 11. Trajectories determined from the overhead-view cameras of the motorcycle and the dummy before and after impacting the steel guard rail (Figure 10)

Figure 11 shows the trajectories of the motorcycle and dummy before and after impact onto the

protection system as determined from the analysis of the film from the overhead-view cameras.

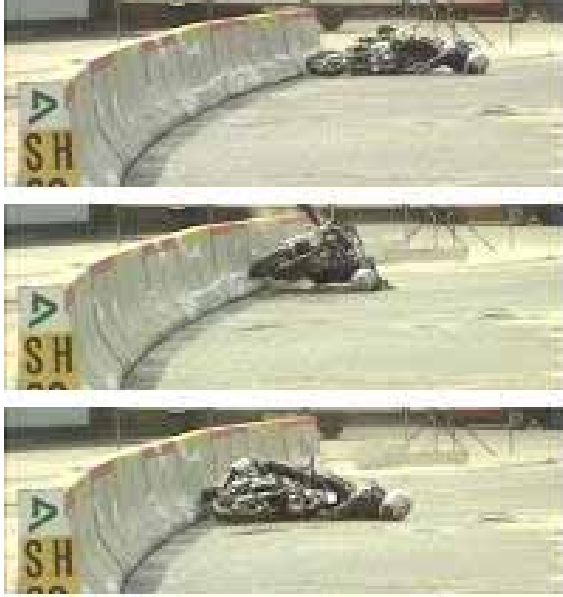
Figure 12. Full-scale crash test where the motorcycle impacts the concrete barrier protection system in a sliding position

The impact where the motorcycle slides onto its side into the concrete barrier is shown in Figure 12. The motorcycle left the sled at 59 km/h and the front wheel impacted the barrier at 46 km/h.

Deceleration of the motorcycle and dummy were not as rapid as during the impact where the motorcycle slid into the guard rail made from steel. Nevertheless the measured dummy decelerations for the primary impact were high, indicating a risks of severe and life-threatening injuries. The dummy head loads again lay clearly above the corresponding biomechanical limits.

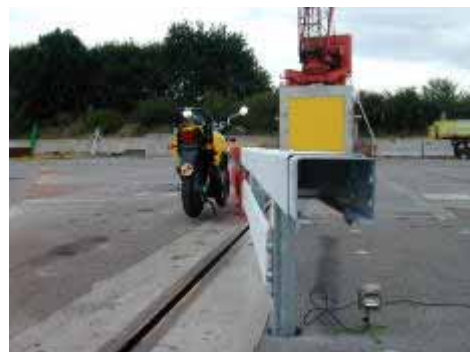
Figure 14. Modified guard rail system with respect to better protection for impacting motorcyclists

Figure 14 provides some information in regards to structure and the geometry of the modified system. The system is a so called “Schweizer Kastenprofil” consisting of sigma posts and a closed box-shaped profile at the top. An additional underrun protection board was mounted near to the ground to prevent both the direct impact onto a post and movement of the motorcyclist underneath the barrier protection system.

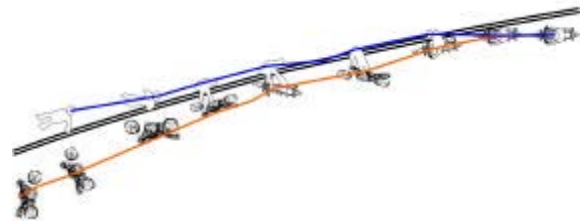
Figure 16. Trajectories of the motorcycle and dummy determined from the overhead view camera before and 230 milliseconds after impacting the modified steel guard rail system (see Figure 15)

The trajectories of the motorcycle and dummy before and after impact onto the protection system determined from the analysis of the film from the overhead-view cameras is shown in Figure 16. The characteristics of the trajectories are similar to the corresponding crash test onto the concrete barrier (compare Figure 8 and Figure 9 to Figure 15 and Figure 16). The motorcycle reached the final rest position 23 m after initial contact primary impact. In the case of the dummy, the distance between the location of the initial primary impact and the final rest position was measured as 22 m.

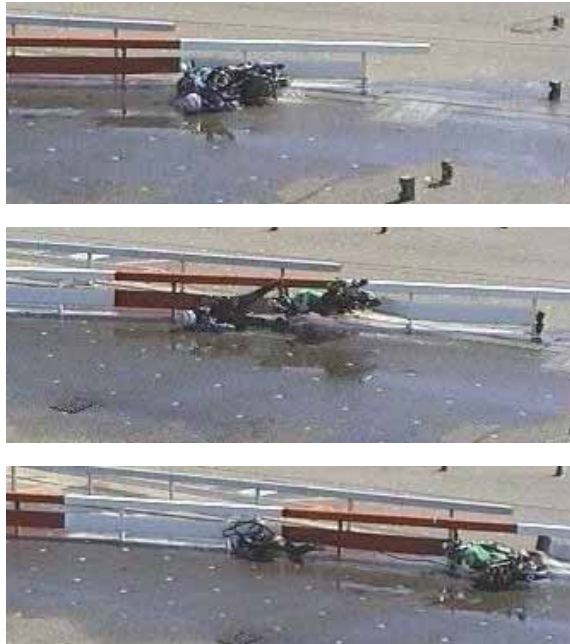
Figure 17. Full-scale crash test where the sliding motorcycle impacted the modified steel guard rail system

Figure 17 shows the crash test where the motorcycle and dummy slides on the road surface. The motorcycle left the sled at 60 km/h and impacted the barrier at 54 km/h. Due to the impact the underrun protection board broke and the motorcycle struck a Sigma post. The dummy separated from the motorcycle immediately after the initial primary impact and then the helmeted head struck the underrun protection board.

Table 6 gives an overview of measured dummy loads related to the primary impact and to the secondary impact. For the primary impact into the protection system all measured dummy loads were clearly less than their corresponding injury tolerance limits. However the measured 3-ms-96 g head acceleration during the secondary impact is above the tolerance limit of 80 g. Also the HIC in the secondary impact with a value of 510 but clearly beneath the limit of 1,000 is relatively severe.

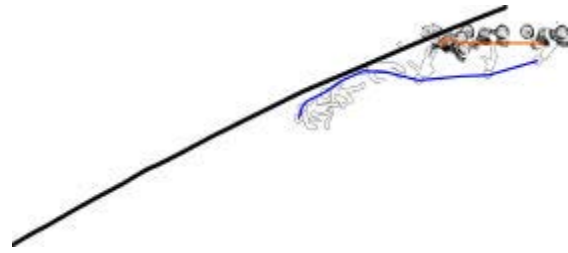
Figure 18. Trajectories of the sliding motorcycle and dummy determined from the overhead view camera before and after impacting into the modified steel guard rail system (see Figure 17)

The trajectories of the motorcycle and dummy before and after the impact into the protection system determined from the analysis of the film from the overhead-view cameras is shown in Figure 18. The distance between the location of the initial primary impact and the final rest position is 1 m for the motorcycle and 7 m for the dummy.

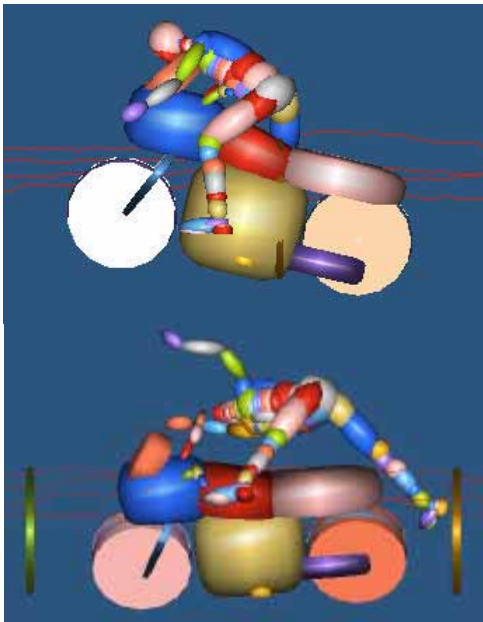
Figure 23 MADYMO simulation showing an upright seated rider on a motorcycle crashing into a wire rope barrier at 60 km/h and 12°

Figure 23 shows the kinematics for an upright rider on a motorcycle impacting a wire rope barrier. The calculated injuries from the simulations suggest that serious injury would result regardless of speed and impact angle.

In all simulations the motorcycle slides along the wires until it hits a post, squeezing and trapping the rider's leg against the wires as it does so. The post contact causes the motorcycle's front wheel to snag lifting the front of the motorcycle up and throwing the rider's torso and head forward. Because the rider's leg is trapped between the motorcycle and the wire ropes and the foot snags in the ropes, the head and torso slap into the front of the rising motorcycle. Eventually the leg becomes free as the motorcycle rotates and the rider is then catapulted over the barrier. This is a different result to the concrete barrier where the rider was thrown over the barrier with relatively little snagging or deceleration.

In both the 60 km/h and 80 km/h impact speeds at an angle of 25°, the motorbike throws the rider into the air with the rider hitting the ground head first. Hence the high HIC.
